#10 - SITE GRADING AND DRAINAGE PROBLEMS

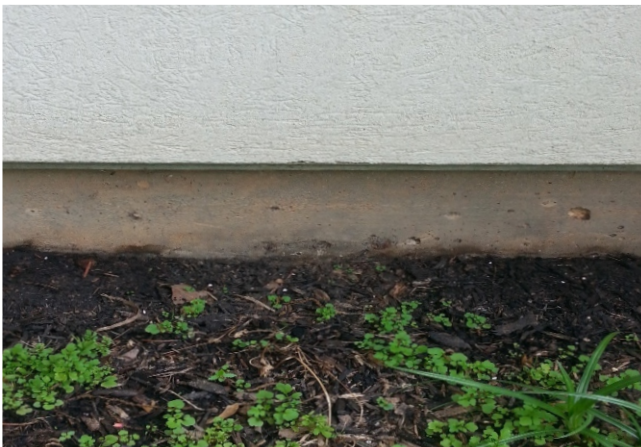
Right.

High grading around the foundation is one of the most common issues identified on inspection reports. The proper minimum clearance between the facade and the soil is 4 to 6 inches. High grades are most commonly found in planter areas. Homeowners often place new mulch without removing the old, creating potential issues.

Drainage problems are avoidable with proper grading. Site grading should always slope away from the foundation for at least 5 feet. Gutter downspouts should always direct the water at least 5 feet away from the foundation or deposit into a site drainage system.

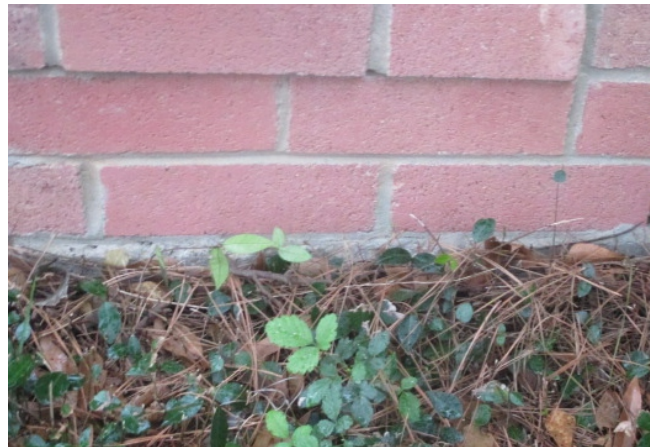
Wrong.

Ponding water around a foundation can cause a loss of support and settlement. When water sits against the foundation without proper drainage, the ponding can result in wood rot and mold throughout the structure.

Siding, stucco and stone/brick veneers are not waterproof, so water easily penetrates the exterior walls. High grading can obstruct the weep holes that allow the moisture to escape. If the drainage is blocked, the moisture gets trapped in the wall, promoting more wood rot and mold.

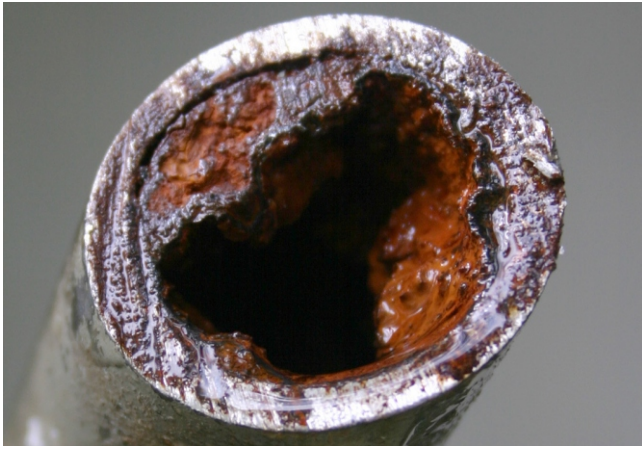
“Galvanized” pipes are zinc-coated pipes that were meant to prevent rusting. Galvanized piping was common until the 1950s and lasts around 40 to 60 years.

When galvanized pipes are found today, they are usually near the end of their lives and in need of replacement.

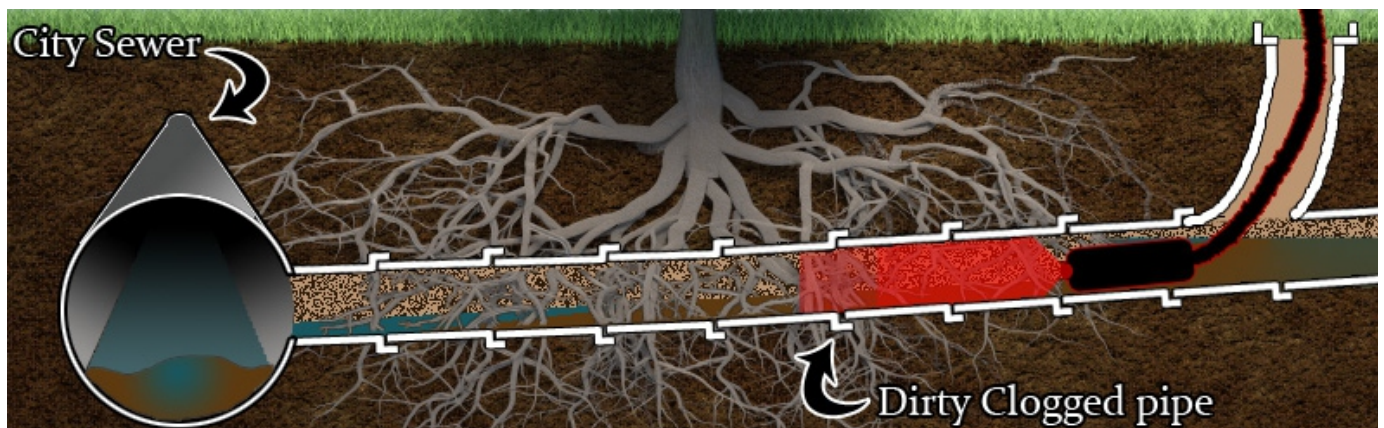
Clogged or obstructed pipes are extremely common. Many times, underground pipes are damaged by tree roots, which are drawn to pipes for their moisture. Signs of main drain and sewer issues are floor staining or sitting water of unknown origin. Homebuyers often look for roofer or plumbing stickers, which indicate the pipes have been well-maintained.

Sewer line scans can identify any plumbing issues, giving insight to any potential repairs.

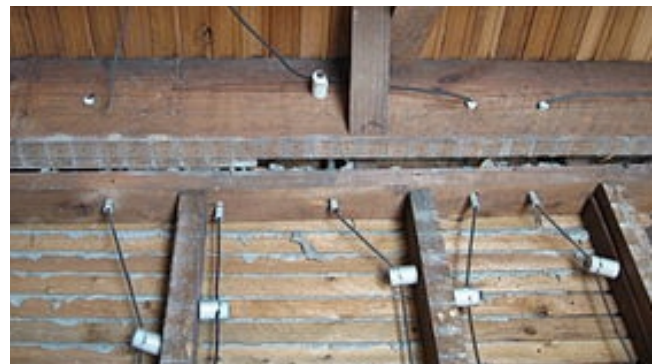
You may come across knob and tube wiring in homes built between 1880-1940. This type of system is designed so that heat from the wires can dissipate through an open space. However, this wiring is often prone to overheating when in contact with insulation or if the wires are too close together. The high risk of fire leads insurance companies to charge higher premiums or even deem a home un-insurable.

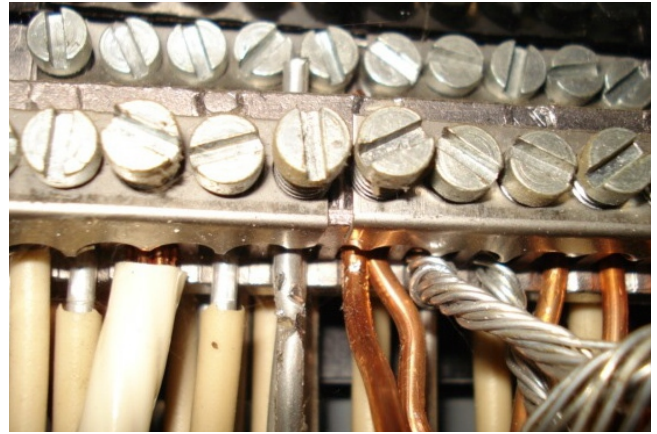
Aluminum branch circuit is a permitted method of wiring with the appropriate installation methods and materials. However, careful workmanship is required because of aluminum's unique electrical properties and its delicacy. Poor workmanship has led to many improper connections, which result in overheating and fire hazards. These systems face the same insurance-related problems as knob and tube systems. If improper connections were made, repairs are possible with a highly skilled technician.

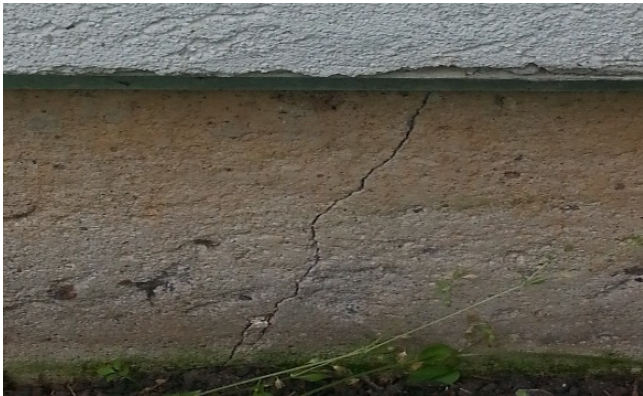
Hairline Cracks (1/16 inches or Less)

Hairline cracks are most likely caused by shrinkage during the curing process of poured concrete. They do not present any concern.

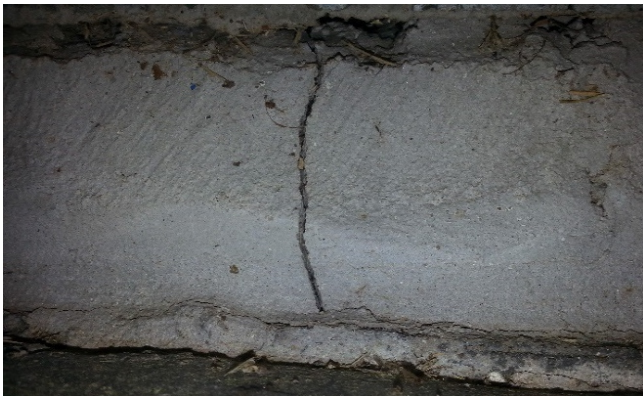
Cracks 1/8 inches or Less

Cracks this size may indicate either shrinkage from curing or foundational movement. This crack should be sealed and monitored.

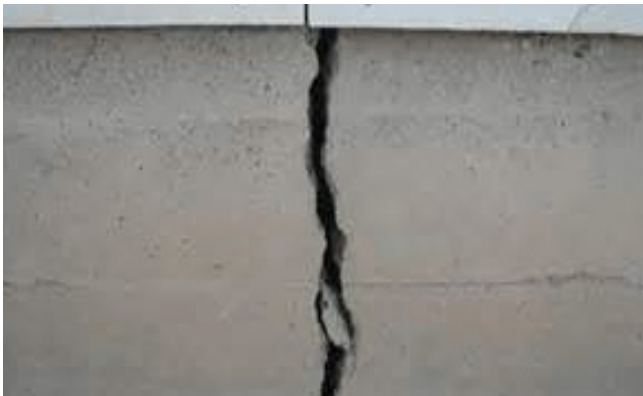
Cracks 1/4 inches or More

Cracks this large are most likely due to foundational movement. A structural engineer should be consulted.

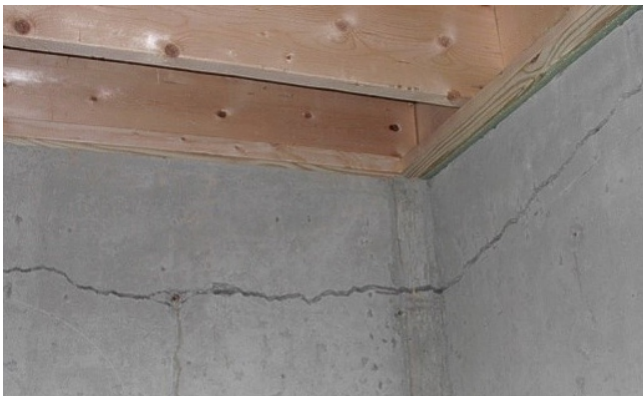
Basement Foundation Walls

Horizontal cracks found in the basement can be minor or major. Some minor cracks may be repairable DIY-style. Depending on their width and severity, some cracks may require stabilization repairs such as wall tiebacks or carbon fiber reinforcement. An DRHI inspector would typically suggest a consultation with a structural engineer.

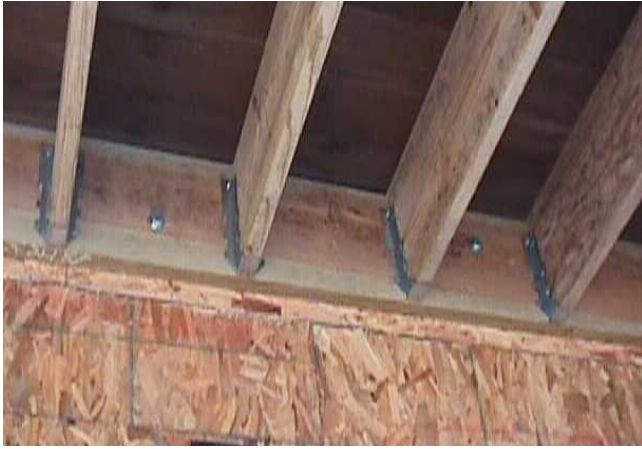
Poor deck conditions are often visible to untrained eyes. Check for post deterioration or chipped paint. Less obvious red flags exist in a deck's support system. Unstable support is often characterized by uneven or sloped boards.

Industry standards require all ledger boards be bolted to the house, and joist hangers must be installed on every joist with the appropriate type and amount of fasteners (left). All decks should have adequate fall protection including handrails and spindles.

Most deck issues can be self-repaired by a homeowner. For any structural concerns, a homebuyer can request an engineer consultation. Deterioration can be prevented with adequate maintenance and updated sealant.

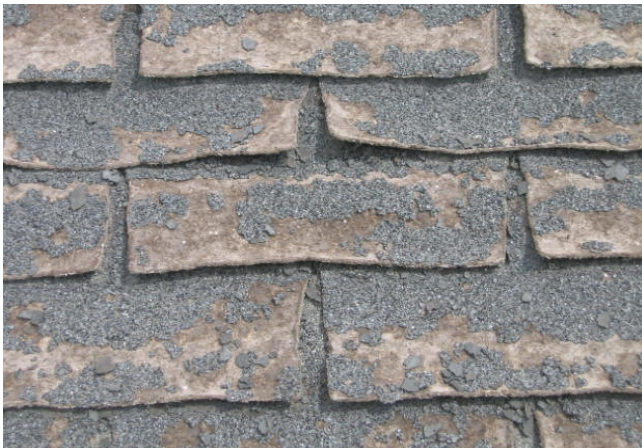
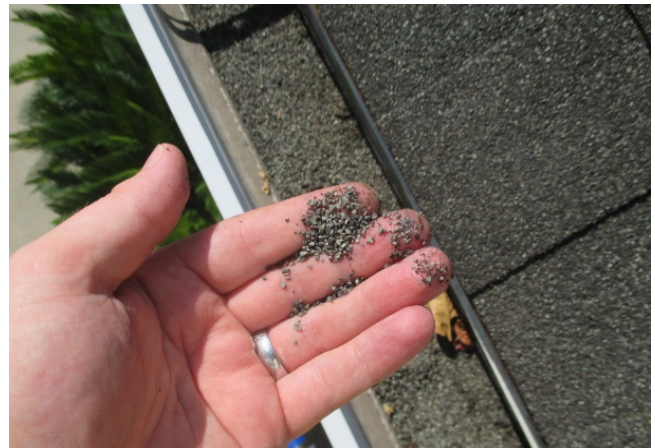
Roof condition is often a key factor in home appraisal. Excessive granular loss (pictured above) is a key indicator of poor condition. Note that the south-facing side of a house always displays the most wear.

Replacing or repairing a roof is a significant expense for a homeowner. Buyers will avoid a house entirely if the roof is in need of repairs. The condition should always be a consideration in an offer. For older, worn roofs, a homeowner can get a Roof Certification from a roofing company or a general contractor, indicating a sufficient condition.

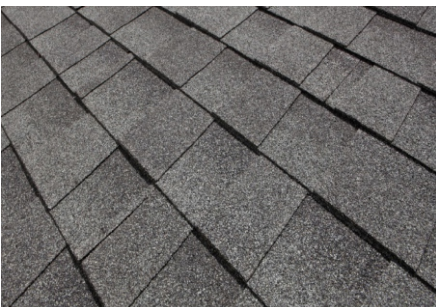
New, 0-5 years

Little to no granular loss
No cupping or curling
Straight edges

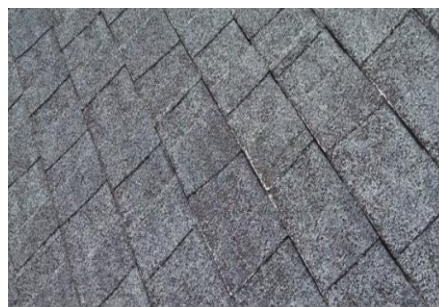
Medium Wear, 5-15 years

Mild to moderate granular loss
Some cupping or curling

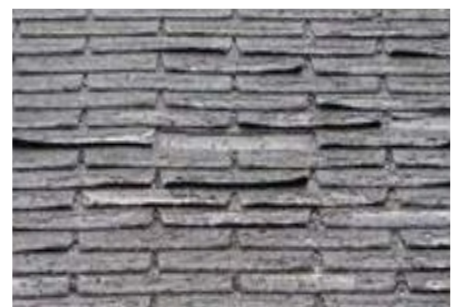
Heavy Wear, 15+ years

Excessive granular loss
Excessive cupping or curling
Deformed edges

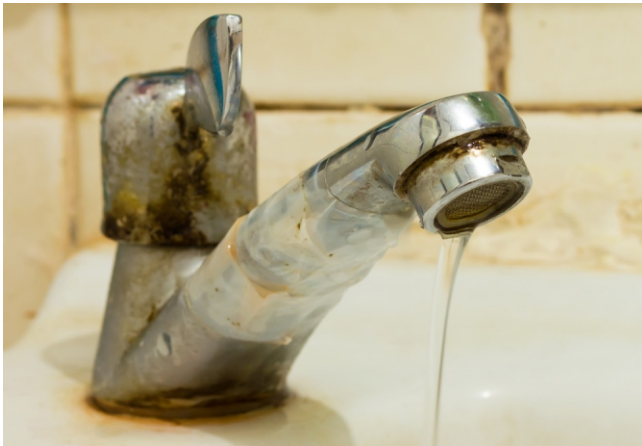
Small amounts of mold and mildew around showers, tubs and sinks are normal (above, left). Small amounts of mold on window sills are normal and most likely caused by condensation. These do NOT present a major problem or concern.

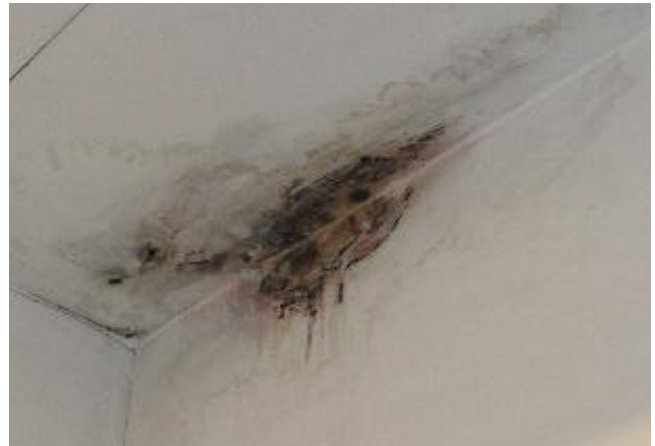
However, mold found on walls or ceilings outside of a kitchen or bathroom DOES signal a problem (above, right). Typically, this indicates a roof or plumbing leak. Any amount of mold to the sides or below a window or door indicates a leak as well. These are definitely a major problem.

If you suspect a home has mold, encourage the owners to schedule a mold inspection immediately. Locating mold as soon as possible is key to saving thousands of dollars.
